A Machine Vision System for Monitoring Railcar Health: Preliminary Results

**by John M. Hart,* Narendra Ahuja,*
Christopher P.L. Barkan* and David D. Davis**

Summary

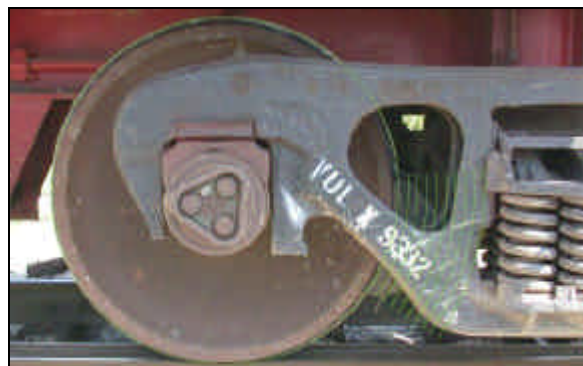
Several algorithms have been developed that can identify the location of particular parts of a railcar truck. Figure 1 shows that the wheel of the truck has been identified and highlighted in the image. The algorithm has also identified the location of the brake shoe, which has been highlighted as well. This is the first step in the determination of the state of the brake (whether the brake is applied or not) and in the identification of the brake shoe itself. This will then allow the determination of the shoe thickness by calibrated measurement techniques. This thickness measure will be automatically compared to the minimum requirements for brake shoe thickness specified by the AAR (e.g., 1/2 inch for cast iron and 3/8 inch for composite shoes).

Figure 1. Brake Location Identified

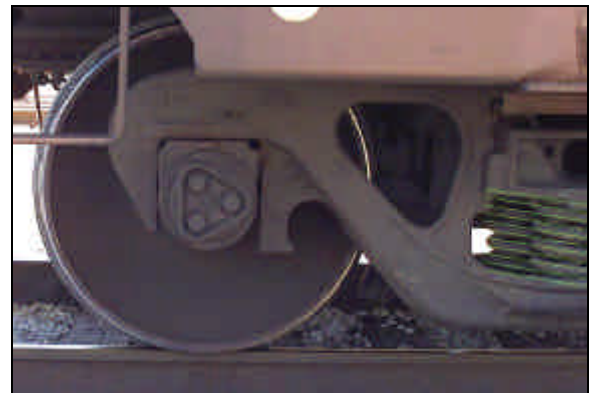
Figure 2 depicts the identification of the location of the spring set and the springs highlighted by the algorithm. From these measurements, the algorithm will be able to determine if the springs are fully compressed. It should also be possible to determine if one of the front springs in the set is missing.

Figure 2. Spring Set Location Identified

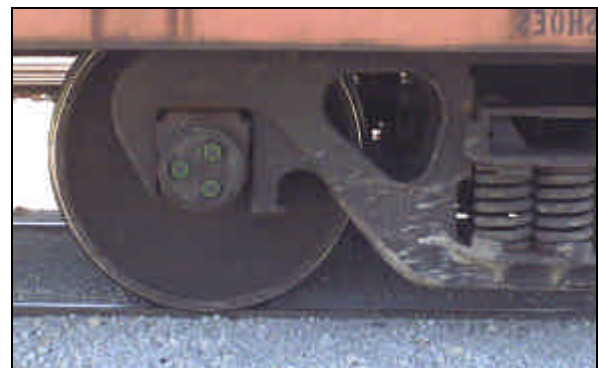
Figure 3 shows that the bearing end cap bolts have been identified and highlighted by the algorithm. The algorithm is robust enough so that the bolts can be identified despite the many types of bearing end cap styles. This algorithm can then determine if the required number of bolts is present. It was tested on an image with a missing bolt provided by the NS car repair shop (Figure 4). Note that the image is not taken from exactly the same perspective as our other images, but the algorithm was still able to successfully detect the missing bolt.

Figure 3. Bearing End Cap Bolts Identified

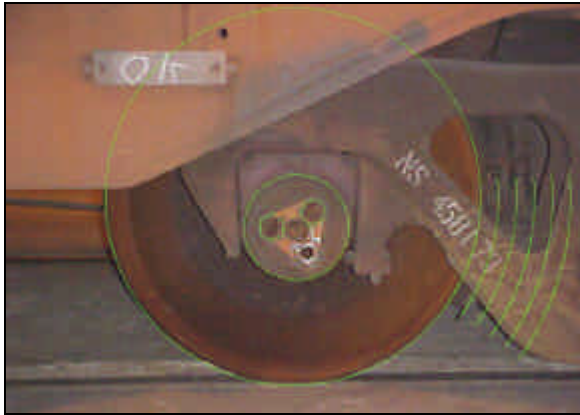
Figure 4. Missing Bolt Detection
