A Machine Vision System for Monitoring Railcar Health: Preliminary Results

by **John M. Hart,* Narendra Ahuja,*
Christopher P.L. Barkan* and David D. Davis**

Summary

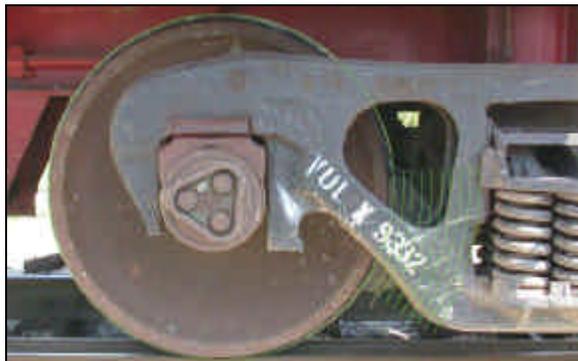
Several algorithms have been developed that can identify the location of particular parts of a railcar truck. Figure 1 shows that the wheel of the truck has been identified and highlighted in the image. The algorithm has also identified the location of the brake shoe, which has been highlighted as well. This is the first step in the determination of the state of the brake (whether the brake is applied or not) and in the identification of the brake shoe itself. This will then allow the determination of the shoe thickness by calibrated measurement techniques. This thickness measure will be automatically compared to the minimum requirements for brake shoe thickness specified by the AAR (e.g., 1/2 inch for cast iron and 3/8 inch for composite shoes).

Figure 1. Brake Location Identified

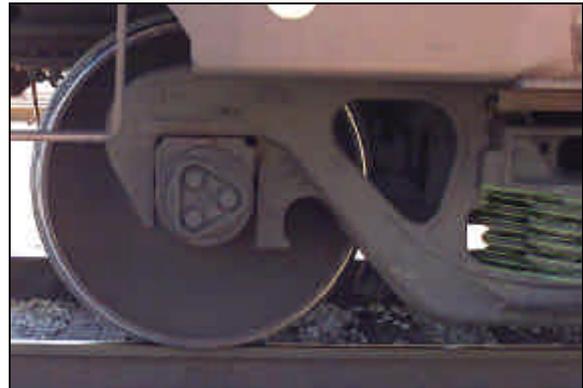
Figure 2 depicts the identification of the location of the spring set and the springs highlighted by the algorithm. From these measurements, the algorithm will be able to determine if the springs are fully compressed. It should also be possible to determine if one of the front springs in the set is missing.

Figure 2. Spring Set Location Identified

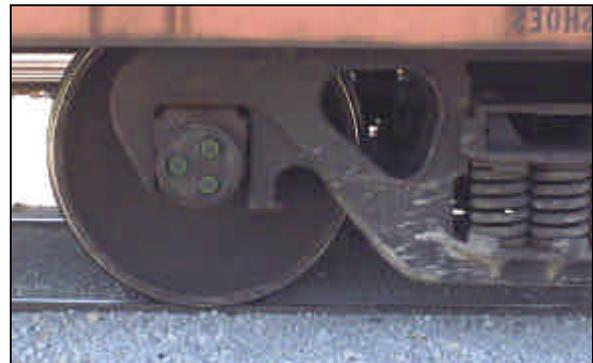
Figure 3 shows that the bearing end cap bolts have been identified and highlighted by the algorithm. The algorithm is robust enough so that the bolts can be identified despite the many types of bearing end cap styles. This algorithm can then determine if the required number of bolts is present. It was tested on an image with a missing bolt provided by the NS car repair shop (Figure 4). Note that the image is not taken from exactly the same perspective as our other images, but the algorithm was still able to successfully detect the missing bolt.

Figure 3. Bearing End Cap Bolts Identified

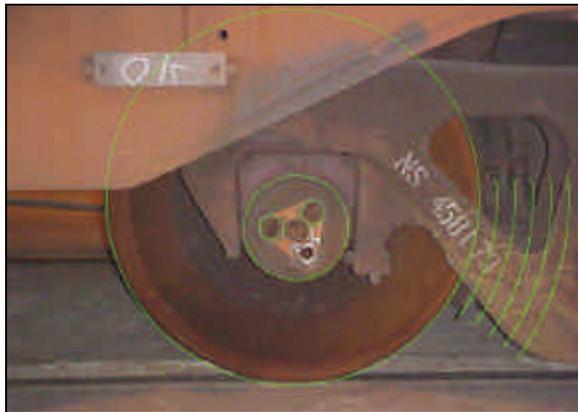
Figure 4. Missing Bolt Detection
